## REPORT

### Internal Task Force

No.: PRO-X15-0030  
Rev.: 01M  
Date: 2018-04-09  
Page: 1 of 25

In the region of Barcarena, Brazil, where Alunorte Alumina Refinery is located, a heavy rainfall occurred on the night of the 16<sup>th</sup> of February 2018 followed by significant rainfall over the next 10 days.

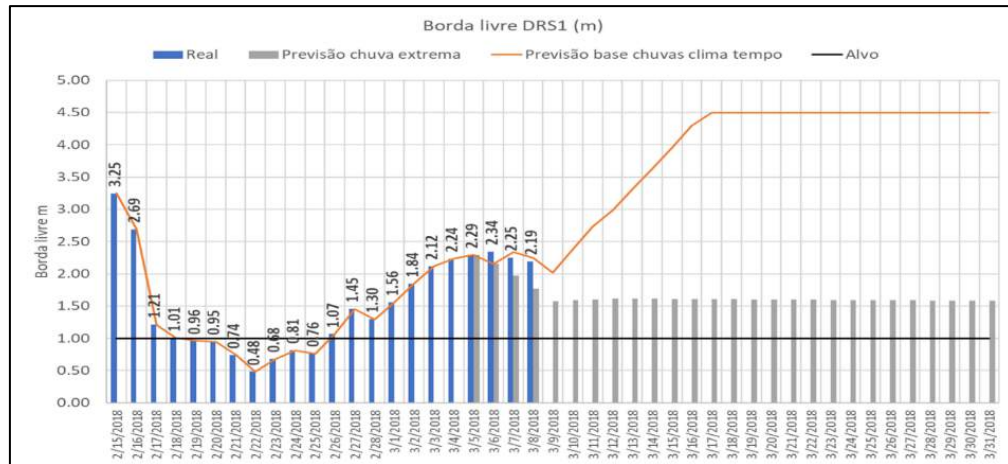
Around midnight (00:00) February 17<sup>th</sup>, the flows from BC1 and BC2 were stopped due to the reduced ETP capacity. The freeboard of DRS1 is shown in Figure 4.3: The variations in the freeboard (borda livre) in DRS1 as measured (taken from the Alunorte Plant Operations system - blue is actual, grey is forecast for extreme situation) Figure 4.3. The heavy rainfall the 16<sup>th</sup> and 17<sup>th</sup> reduced the freeboard level from 3.25 m on February 15<sup>th</sup> to 1.0 m on February 18<sup>th</sup>.

The freeboard level was below minimum requirement of 1 m from around February 18<sup>th</sup> to 26<sup>th</sup>.

Figure 4.3: The variations in the freeboard (borda livre) in DRS1 as measured (taken from the Alunorte Plant Operations system - blue is actual, grey is forecast for extreme situation)

February 22<sup>nd</sup> Operations started emergency works to place out sand bags and heighten levels around DRS1, to avoid overflow as a safety measure.

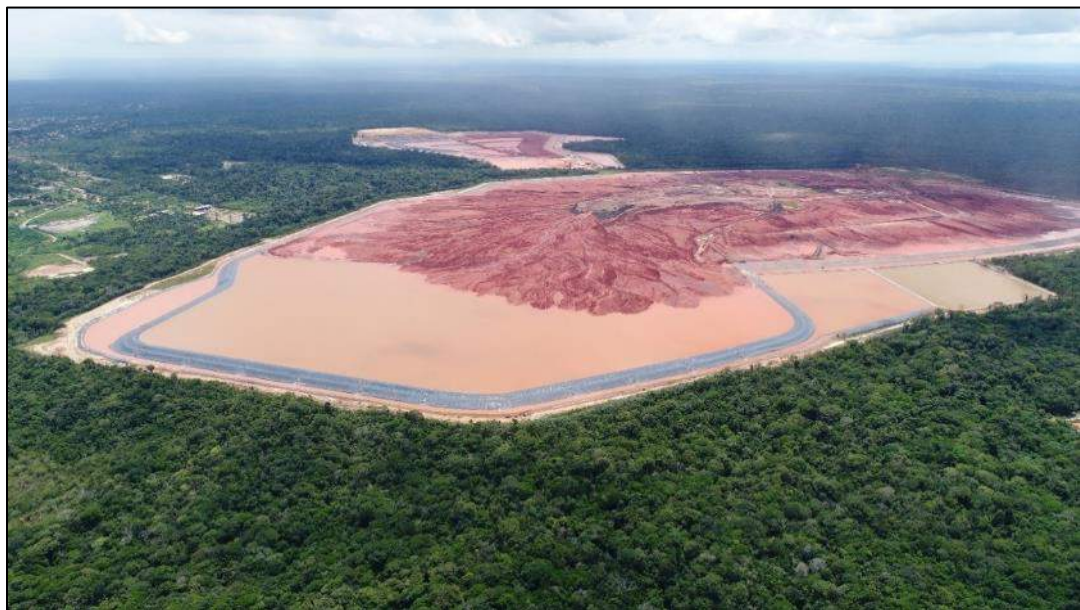
The Task Force has concluded that DRS1 did not overflow during the entire rainfall event. Site inspection along the full perimeter of DRS1 and inspection of drone photos and videos confirm this conclusion.

Figure 4.4 DRS1 Drone photo 24.02.2018 – DRS1 seen from north west.

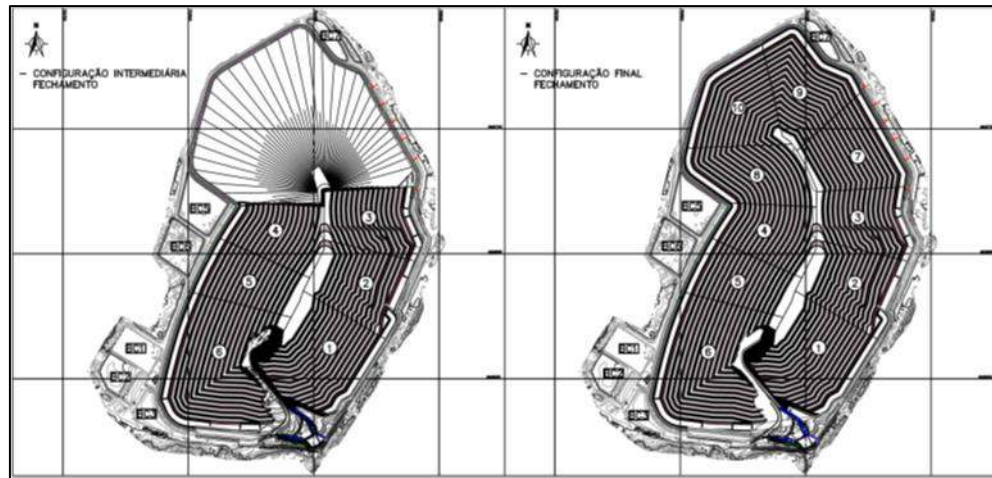
Figure 4.7 DRS1 closing

The closure scenario has investigated the safety of the anticipated slope angle of the residue deposit. It has been checked and confirmed that the minimum safety factor is between 1.6 (profile north) and 3.1 (profile south) at end of construction, compared to a minimum safety factor in Brazil of 1.5.

Progress closure project for DRS1.

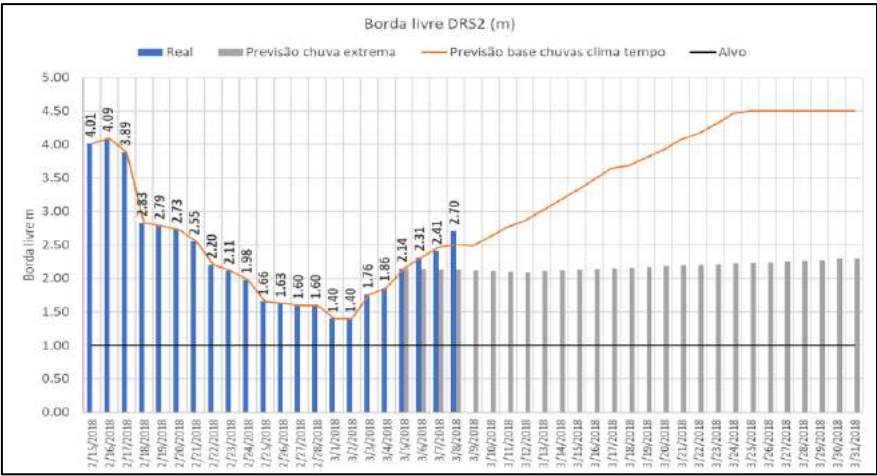
Figure 4.9: Free board of BC201 and 202 in DRS2 during the rainfall event; blue is actual, grey is forecast for extreme situation

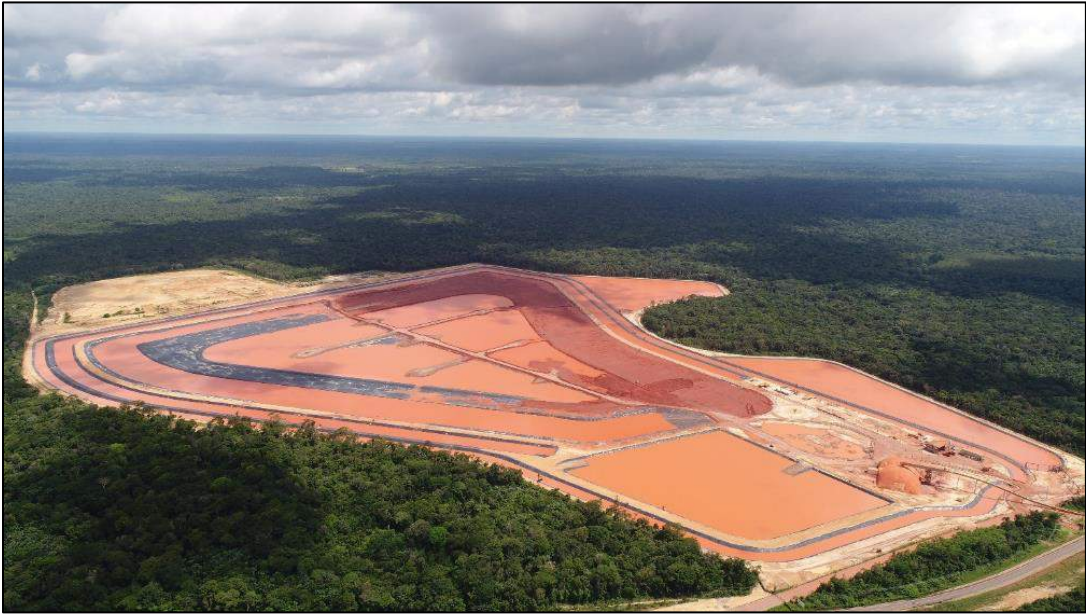
The Task Force has concluded that DRS2 did not overflow during the rainfall. Site inspection along the full perimeter of DRS2 and inspection of drone photos and videos made available show no signs of overflow. Figure 4.9 shows the free board curve for BC201 and 202 from the Operational system, shows that the free board is decreasing from 4.1 m February 16<sup>th</sup> to 1.4 m March 2<sup>nd</sup> due to the rainfall. During this period, no pumping out of the reservoir was performed, the water was kept in the reservoir to utilize BC-6 for DRS1 effluents. Pumping to BC-6 started March 3<sup>rd</sup>.

Figure 4.10: DRS2 drone photo March 2<sup>nd</sup>, 2018 –DRS2 when the free board was the lowest during the event.

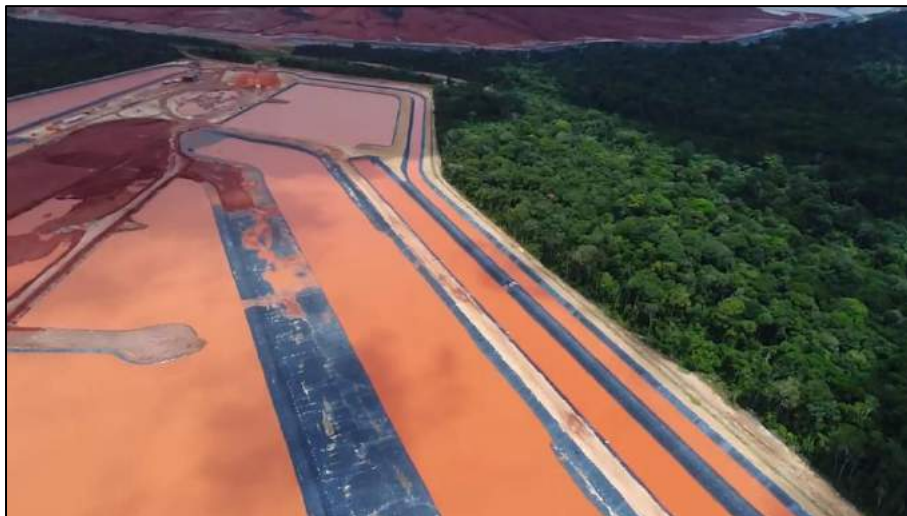
The picture below shows a flow through a dedicated low point from the waste reservoir according to design.

*Figure 4.11: Section of DRS2 – Drone photo March 06<sup>th</sup>, 2018*

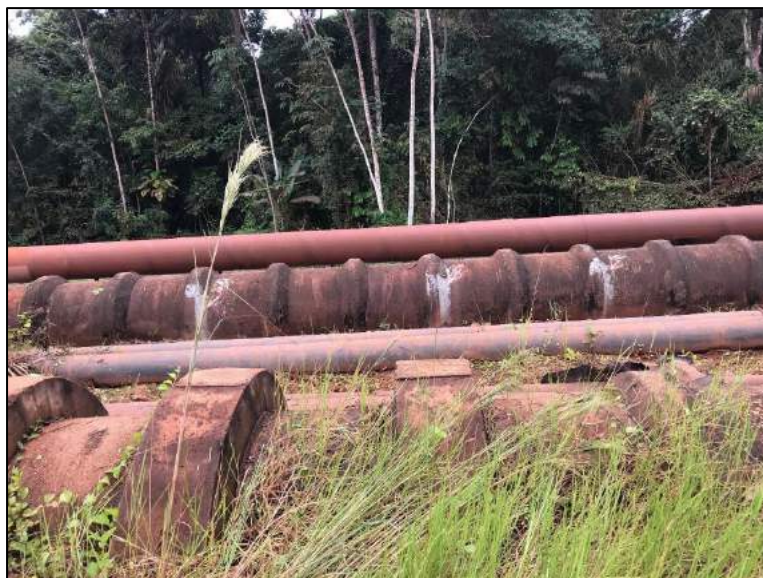
The pipes have been inspected for cracks on a regular basis and cracks are repaired as soon as they are discovered. All repairs are documented in reports.

*Figure 4.15 Example of small repairs of concrete pipes*

Install new transfer pipes and pumping facilities from the DRS1 to Effluent Treatment Plant. This has already been sanctioned by Alunorte as part of the Water Management Improvement Project.

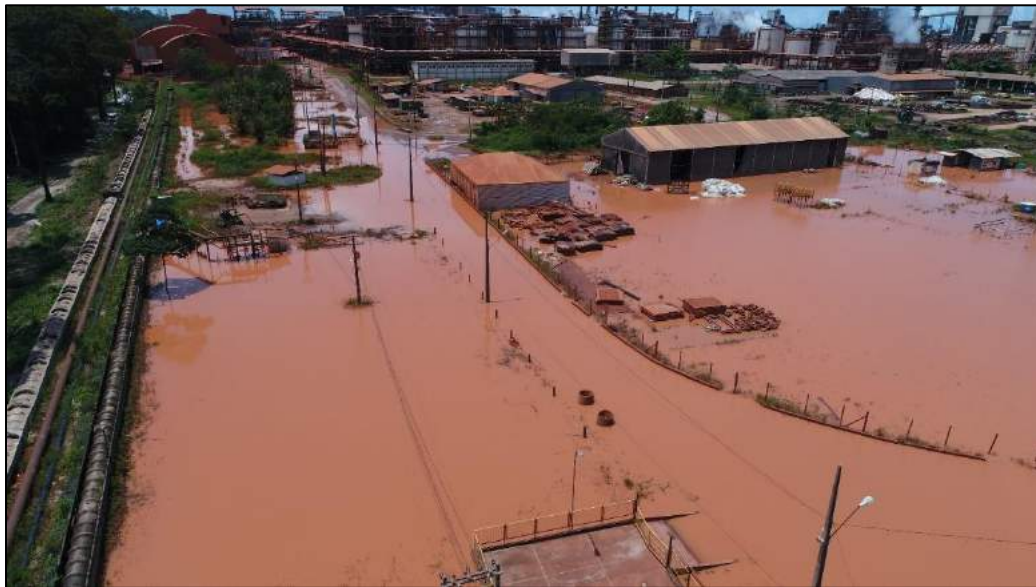
*Figure 4.20 Area 45 during the flooding*

Build more holding basin capacity in the old lay down area (Area 45). This is already sanctioned by Alunorte. A new storm water system including holding pond capacity and sufficient pumping system will be constructed.
